MARSHALL LAKE DAM

NDI ID NO. PA-00985

PHASE I INSPECTION REPORT
NATIONAL DAM INSPECTION PROGRAM

JULY 1981

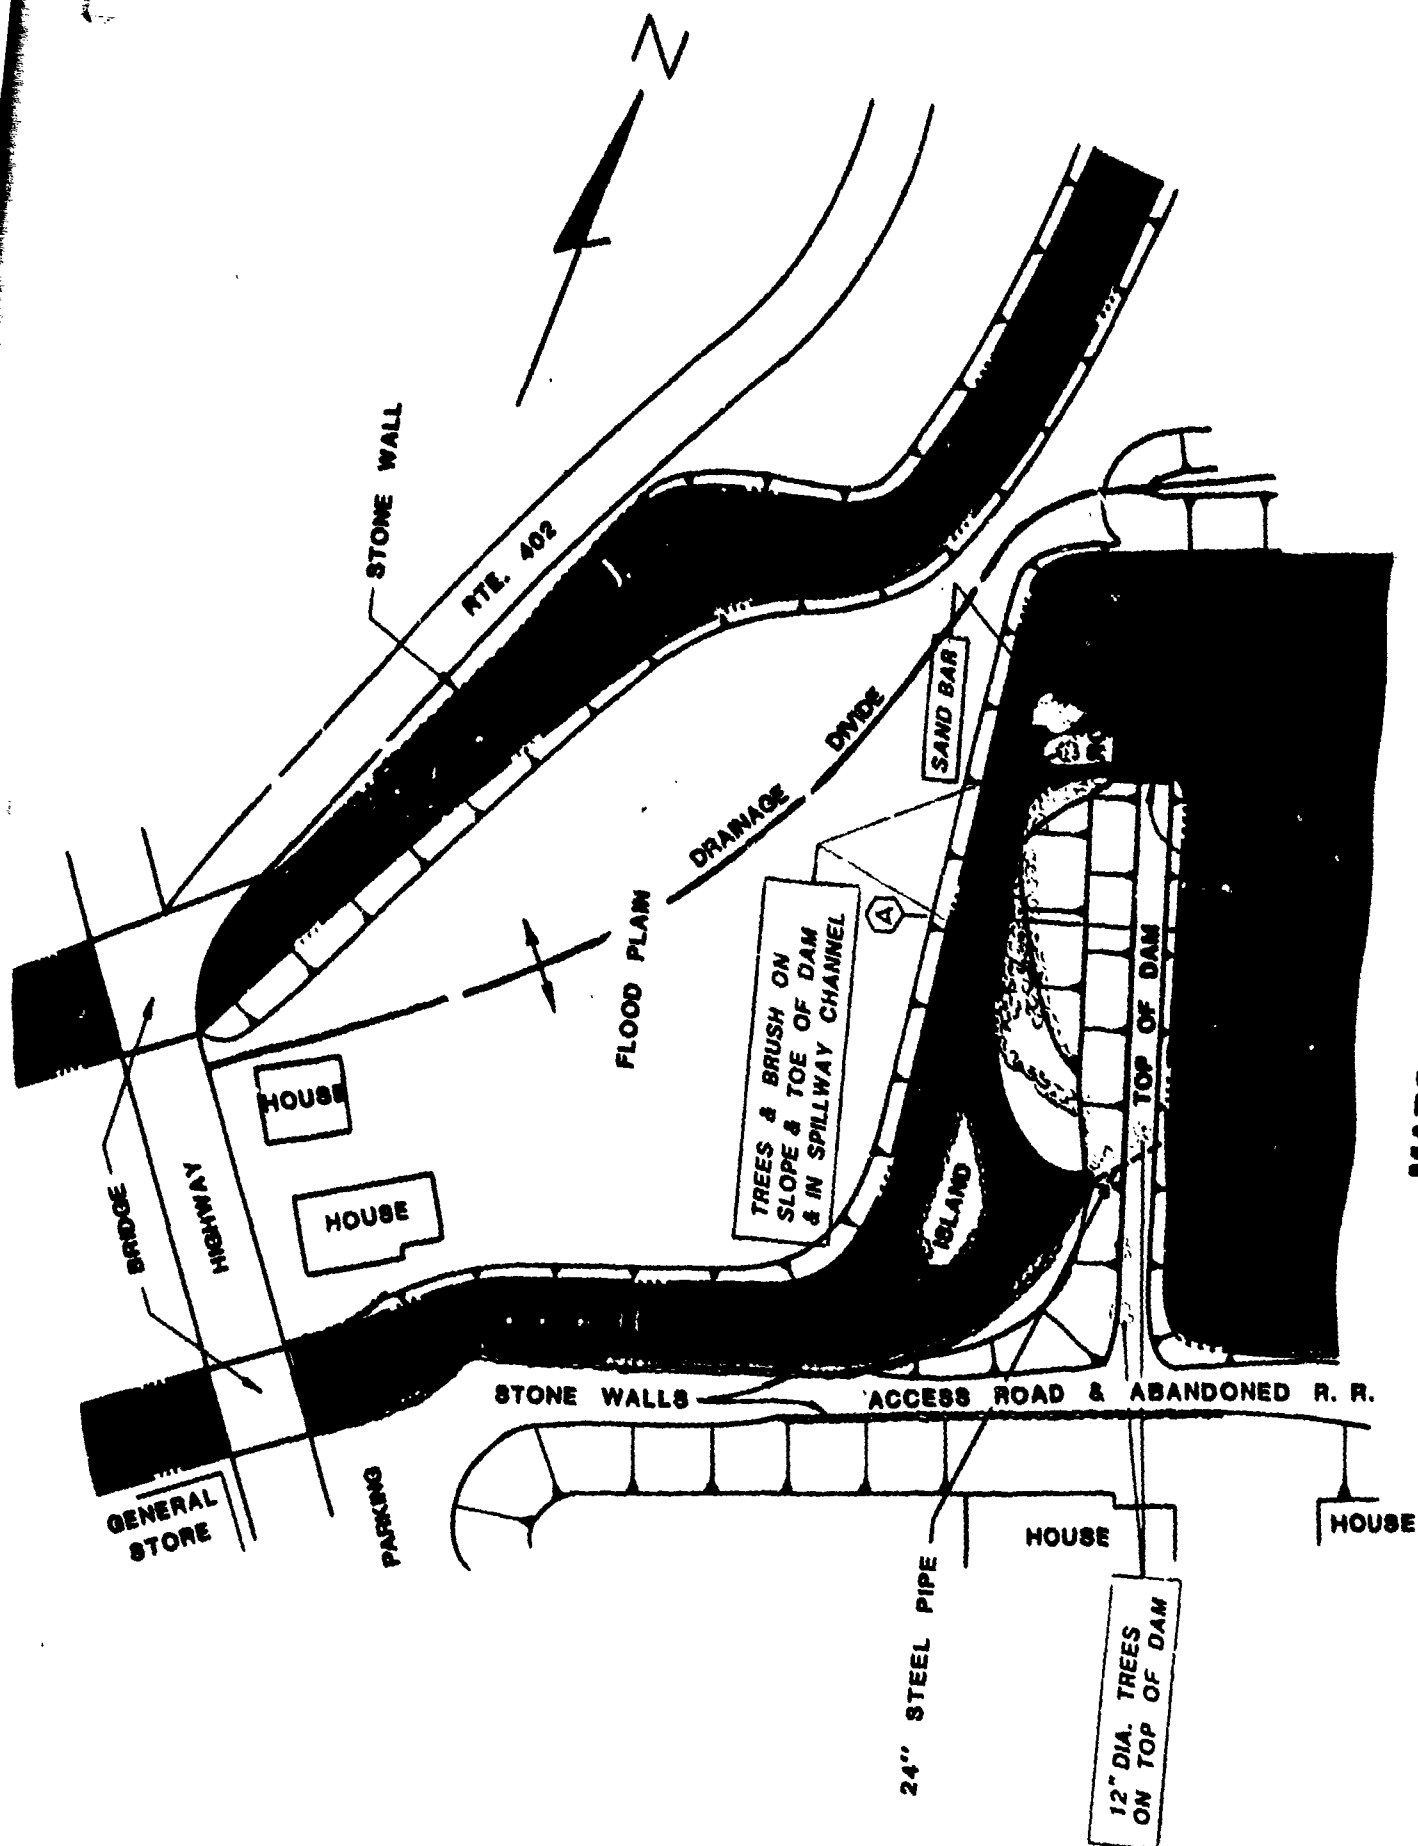
MARSHALL LAKE DAM GENERAL PLAN - FIELD INSPECTION NOTES

a. General: The overall appearance of the dam and spillway is poor. Deficiencies observed during the field inspection are noted on the General Plan, Exhibit A-1 and are described in the subsequent paragraphs. The profile and typical sections of the dam are presented in Exhibits A-2 and A-3 and are based on field survey made on the day of the inspection. The survey datum for this inspection is elevation 469 above mean sea level, a disc in the wingwall of State RTE 402 bridge over Pond Creek. On the inspection date (11/25/1980), the lake level was 0.1 foot above the spillway crest. Visible features of the dam and appurtenant structures are depicted in photographs presented in Appendix C.

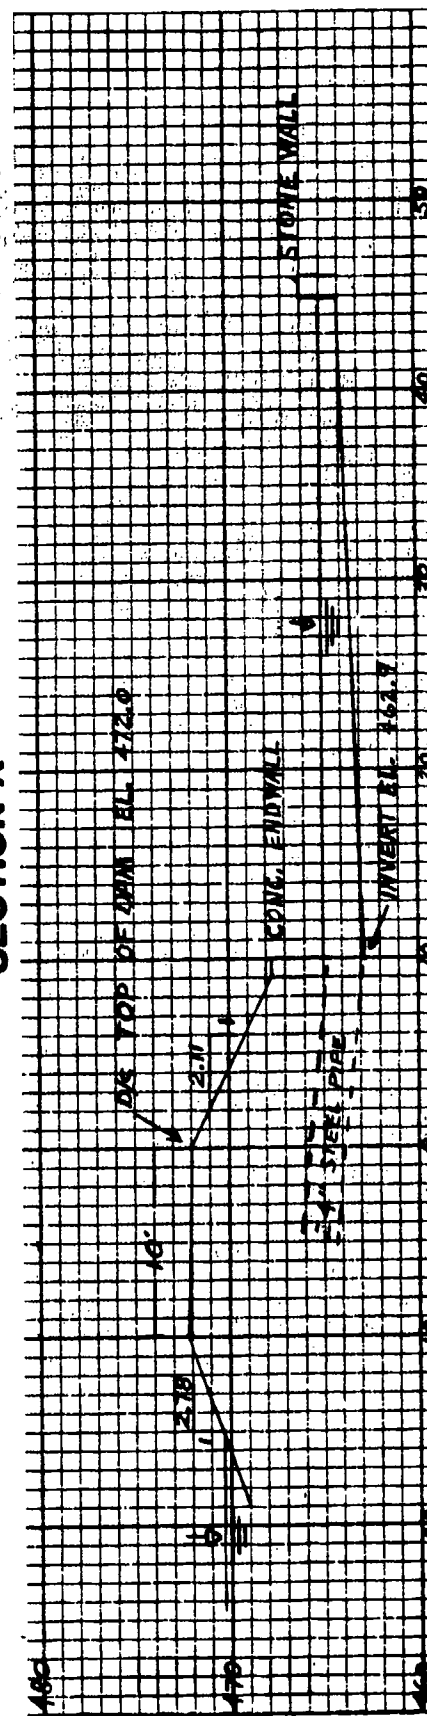
OUTLET WORKS

2. Outlet Works: The outlet works design features are described in paragraph 2.1b.(2)(b). The outlet of the 24-inch diameter steel pipe was submerged on the day of the inspection (see Outlet Works Section, Exhibit A-3 and Photograph 6, Appendix C). The concrete endwall terminal structure appears to be in good condition. There was no visible hoisting mechanism nor means of access to the reported upstream wooden gate at the inlet to the 24-inch diameter pipe.

(3) Locate and operate the submerged outlet works gate, or provide other emergency means of drawing down the reservoir. If the gate is operable, observe the conditions at the toe when the outlet pipe is subjected to pressure flow. Take appropriate action as necessary.
